# Evaluation of Seismic Resilient Characteristics of Traditional Stone Masonry in Mud Mortar Houses

Sital Parajuli <sup>a</sup>, Hari Darshan Shrestha <sup>b</sup>

<sup>a, b</sup> Department of Civil Engineering, Pulchowk Campus, IOE, Tribhuvan University, Nepal

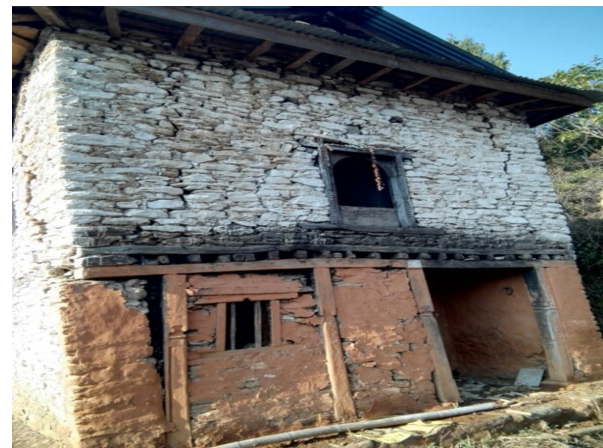
Field based observations revealed that various damage pattern in SMM houses were dependent on their structural parameter. Vertical cracks at wall intersections and corners were observed in SMM houses satisfying overall structural criteria of code along with the presence of timber band. The reason for flexural failure of wall is greater height to length ratio which is not regulated by our code [7]. Lack of vertical reinforcement and lintel band is also a major reason of damage observed in wall intersection.

Figure 9: SMM house satisfying dimensional provision of code

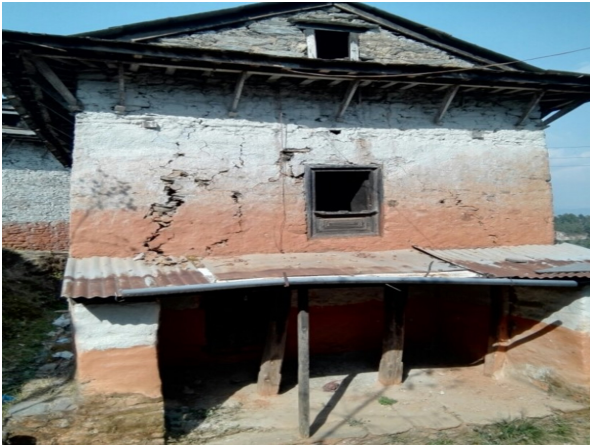
Similar damage pattern were observed in SMM houses without the presence of timber bands where the only difference was the continuous propagation of crack from roof to ground. The result obtained from observation was verified as similar results were obtained in shock table test where the damage in corners are unavoidable even with the presence of sill and lintel band [6].

**Figure 10:** SMM house not satisfying dimensional provision of code

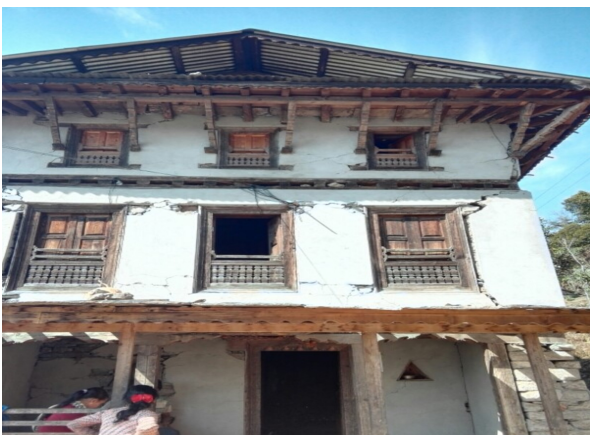
Vertical cracks and separations on openings in transverse wall and diagonal cracking leading from floor to opening were observed in SMM houses with greater than 30% opening in transverse wall. Short piers formed by openings in the masonry walls will face concentrated shear stresses and, as a result, diagonal cracks. Tension cracks may develop in the corners of openings as a result of the lateral loading-induced reverse cyclic stress. Hence, the code has restricted the opening percentage to less than 25% for two storeyed SMM houses. Lack of vertical reinforcement and framing system in opening is the major cause of these damage. However, the width to height ratio of pier in masonry wall, distance between openings and distance of openings from corners is adequately maintained which led to lesser damage in these SMM houses.

**Figure 11:** SMM house with greater opening in transverse wall
