Sand Erosion in Francis Turbine- A Case Study of Middle Marsyandi Hydropower Station

Abstract

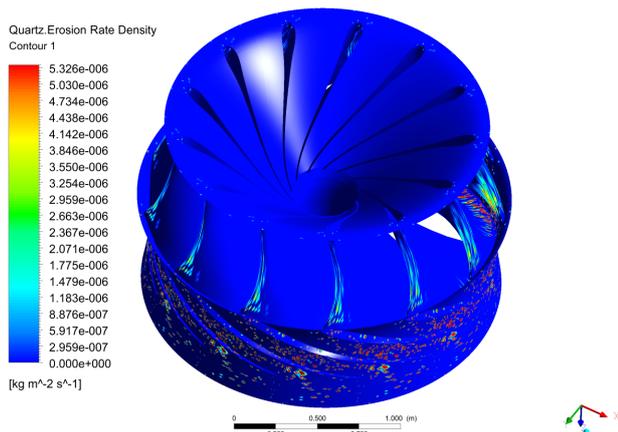
The figure shows the erosion pattern of the MMHPS runner of. It can be observed that the inlet and outlet sides of the blade, specially the leading and trailing edges are highly eroded.

Figure 6: Erosion in runner

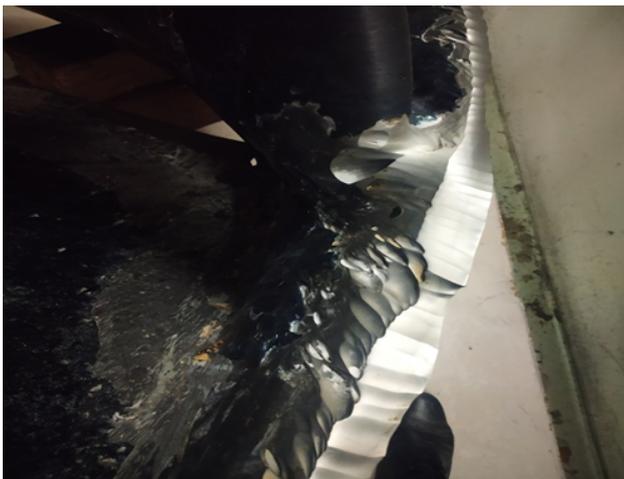
Due to the direct impact of high velocity water emerging from guide vane openings, there was substantial erosion on the inlet (leading) edge of the blades. A larger amount of material loss was found at the inlet portion as shown in the figure.

Figure 12: erosion on the inlet side of the runner

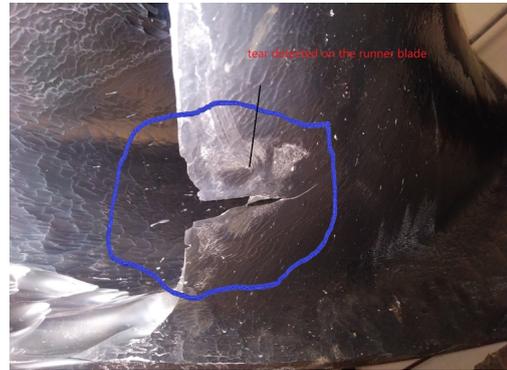
There was a huge amount of coating loss and reduction in blade thickness on the outlets of dismantled runner. It was mainly due to the

curved profile of the runner at the outlet. As a result there was a direct impulse action of high velocity water in the blades as well as a huge amount of pressure drop. Consequently, there was the possibility of the problem of Cavitation also. The loss of coating and blade material at the outlet is shown in the following figures.

Figure 13: Tear detection at the outlet portion

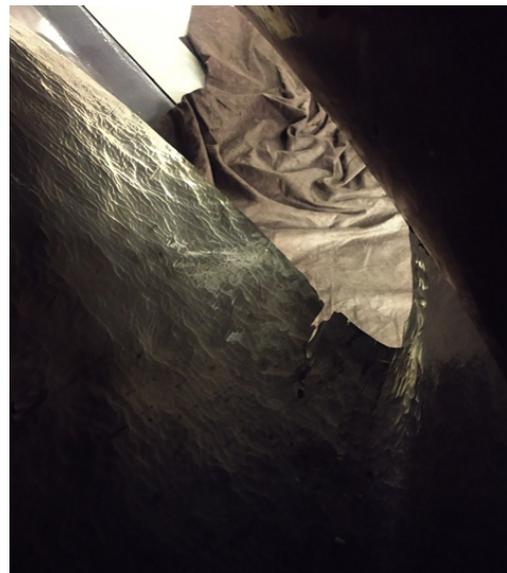
Figure 14: Tear detection at the outlet of the blade

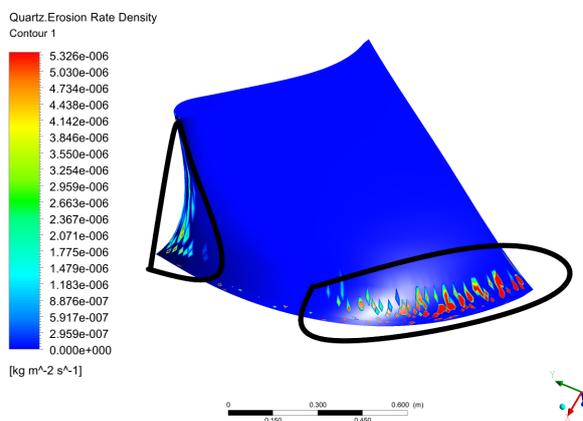
Figure 15: Erosion pattern in the runner blade via simulation

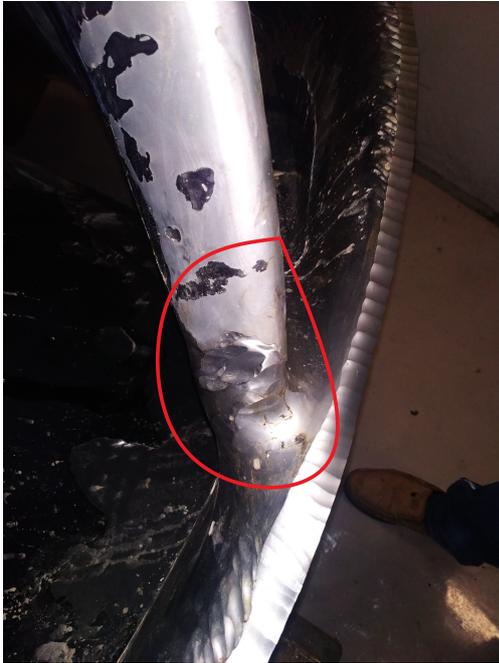
Figure 16: Erosion pattern in inlet side of the blade

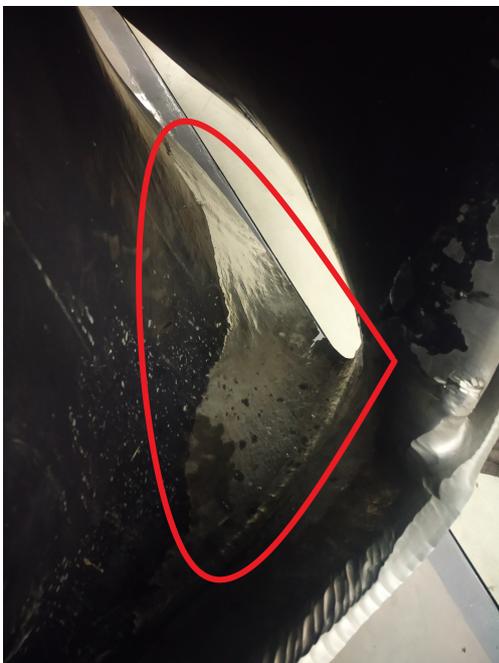
Figure 17: Erosion pattern in outlet side of the blade
