Performance Analysis and Rehabilitation Prospective of Aged Small Hydropower Plant – A Case Study of Fewa Hydropower Plant (1 MW)

Fewa Hydropower Plant is under operation since more than 50 years. Due to continuous deterioration of hydro mechanical and electromechanical components, efficiency of the plant has been reduced significantly. The study investigates the plant rehabilitation prospective after conditional assessment status of power plant along with evaluation of performance indices which indicates current operational scenario. In engineering project investments, financial analysis has been regarded of paramount importance. So, overall financial analysis for assessment of rehabilitation along with performance improvement approaches by increasing efficiency, better operational practices, safety and regulatory capacity of hydropower plants results to improve operational stability and reliability of power supply system thus illustrating main objective of rehabilitation of hydropower projects. One lesson of this exercise is to include hydro plants in rationally planned rehabilitation cycles despite of emergency rehabilitation. Energy generation per annum from rehabilitated plan

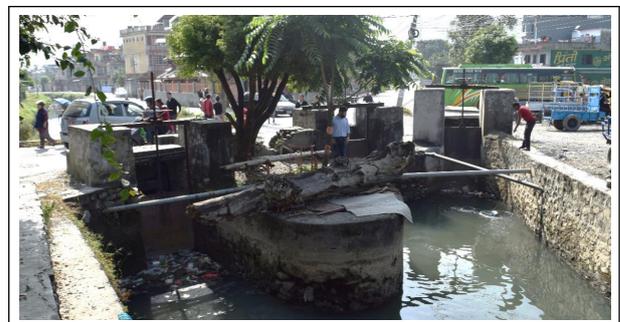
Figure 1: Canal Bifurcation

Headrace Channel: The stone masonry lining is damaged in some stretches and facing the slope stability problems in the right bank whereas in some stretches, it is in complete failure state. The concrete of the concrete lined canal has suffered from surface scouring and the reinforcements is exposed and need maintenance

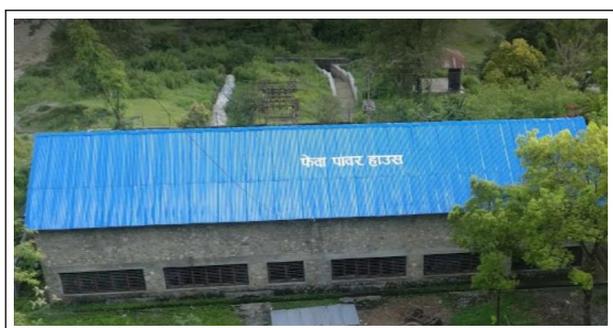
Figure 2: Fewa Powerhouse

Power house and Equipment Foundations: Due to vibrations suffered by base concrete on running of equipment for over 50 years, it may require reinforcements. The machine foundation from the Main Inlet Valve (MIV) to the Draft Tube Bottom level need to be demolished and re-constructed as per new equipment's dimensions.

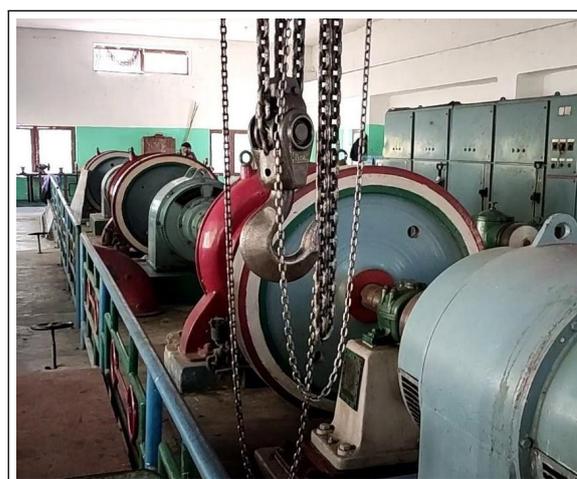
Figure 3: Existing turbine generator units

Turbine: There was a substantial water leakage through shaft seal and head cover. Guide vanes had suffered a heavy wear over the years; therefore, the unit efficiency has decreased significantly and operates below rated output. Turbine runners have undergone some pitting due to cavitation. Guide bearing of turbine has also suffered severe wear. On operation, the shaft vibrates, which affects the units' stability.

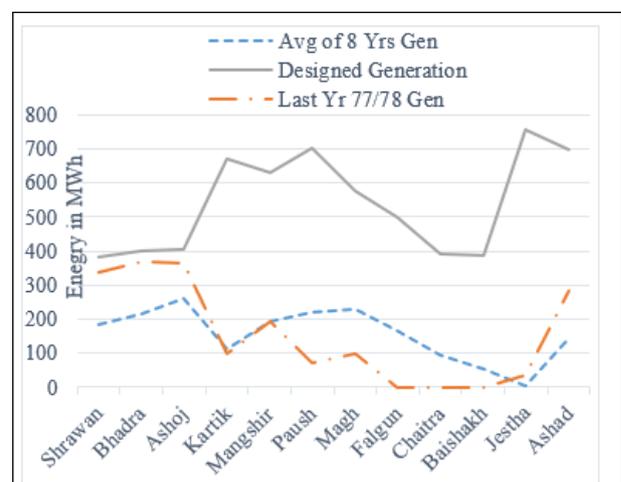
Figure 4: Energy generation profile

Graph below shows the energy generation trend which shows that plant has been generating less energy/power than designed value and average value. The main reason of decrease in energy generating capacity is due to ageing and high efficiency losses.

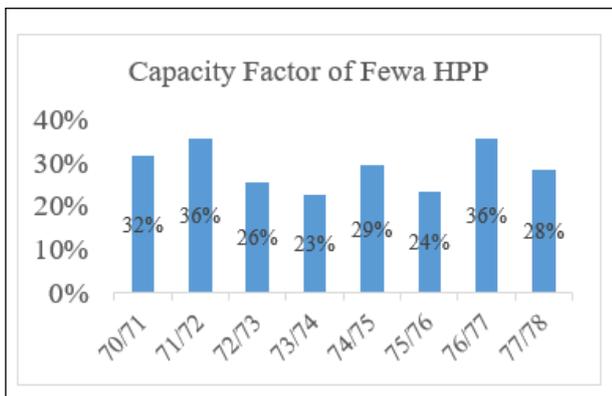
Figure 6: Capacity factor of Fewa HEP

Table 1 illustrates the capacity factor for each year which indicates that maximum of 36% of energy has been actually generated with reference to designed energy. The main reason of decrease in energy generating capacity is due to unavailability of generating units, increase in machine breakdown problems and operational issues.

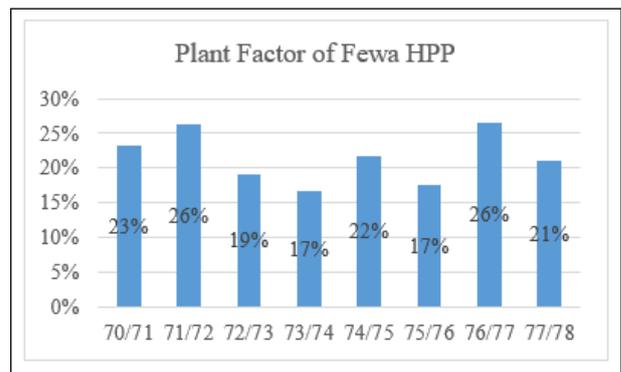
Figure 7: Plant factor of Fewa HEP

Table 2 illustrates the plant factor for each year which indicates that maximum of 26% of energy has been actually generated with reference to maximum possible energy that the plant can generate. The main reason of decrease in energy generating capacity is due to unit and plant outages, machine breakdown problems and maintenance issues.

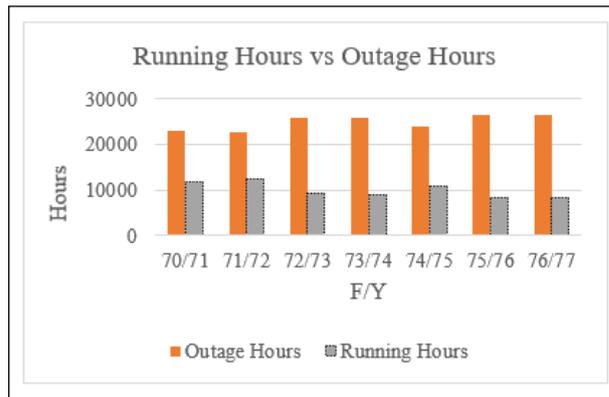
Figure 9: machine availability factor of Fewa HEP

Machine availability is the measure for percentage availability of generating units so as to generate electricity. Table 4 shows determination of machine availability which indicates only maximum of 35% of machine on annual basis is available for loading despite of outage hours. This implies generating units frequently suffers from outages and breakdowns which impacts on operational stability of the plant and low power supply response

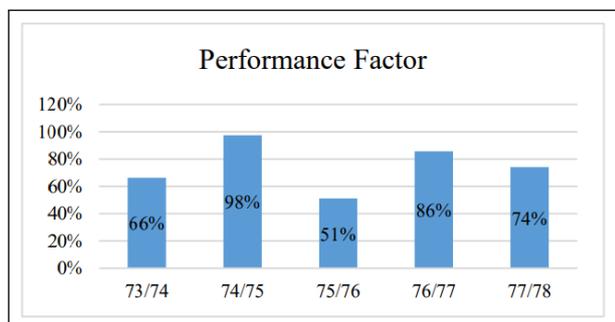
Figure 8: performance factor of Fewa HEP

NEA forecasts energy generation for every year on monthly basis considering prescheduled outages, unavailability for unit operation, maintenance activities and generation trends of previous years and evaluates the plant performance annually. Performance factor of Fewa HPP on annual basis are as shown in table 3.

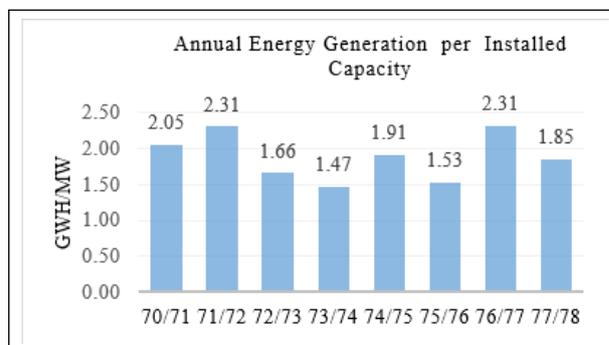
Figure 10: Annual Energy Generation per Installed Capacity

Annual energy generation with respect to installed capacity of Fewa HPP for various fiscal years have been studied and tabulated as below.

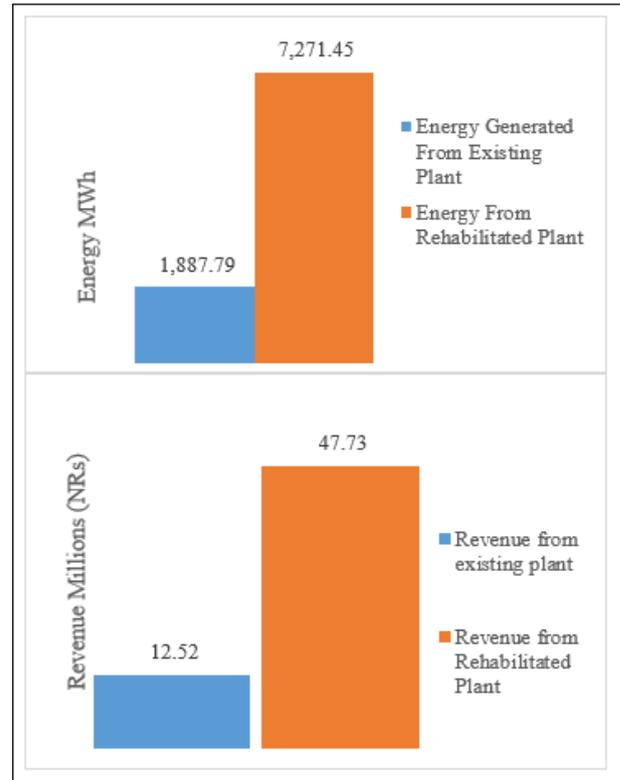
Figure 11: Energy and Revenue Determination

Fewa HPP in existing scenario is generating 1887.79 MWh energy while after rehabilitation it shall generate 7271.45 MWh energy on annual basis. On calculating revenue collection in existing scenario, the plant earns revenue of NRs 12.52 millions while after rehabilitation NRs 47.73 millions in annual basis.
