# Revitalization of I Baha Bahi: Past and Present Condition

Ram Laxmi Nakarmi <sup>a</sup>

<sup>a</sup> Department of Architecture and Urban Planning, Pulchowk Campus, IOE, TU, Nepal

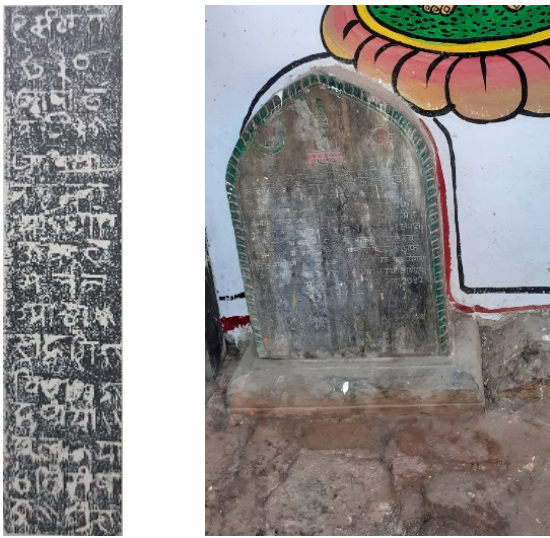
**Figure 2:** Inscriptions on wood and stone inside I Baha Bahi

According to the stone inscription shown in figure 2, which was established on the occasion of the last restoration, situated just beside the door to the shrine room, this Bahi was constructed during the reign of Shree Jaya Jyoti Malla Dev, the King of Patan, in N.S. 547, B.S. 1484 by the five Pradhan Mahapatras.

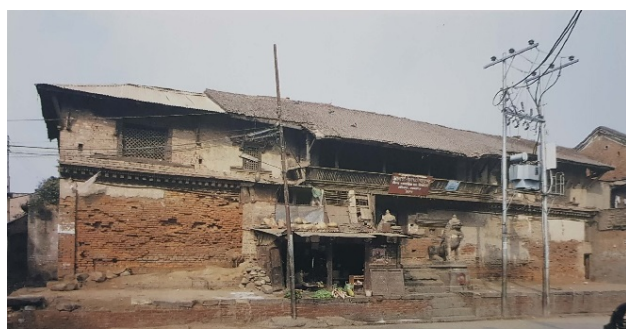
**Figure 8:** Facade, East wing before restoration [4]

During the initial phase (1990 – 1993), the restoration was carried out on sections of the East and North wings of the building. Sections which required repairing were dismantled, refurbished and reconstructed whereas sections that were completely missing were rebuilt. During this phase, technical assistance was extended to the Department of Archaeology by the Agency for Cultural Affairs of Japan, and the cost of restoration was covered jointly

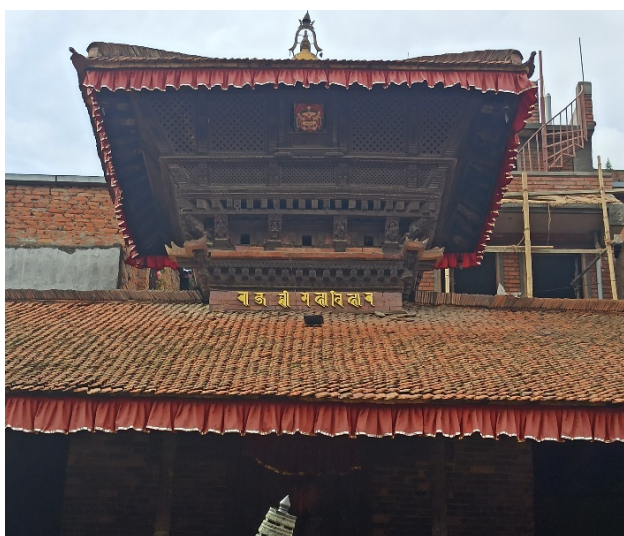
**Figure 12:** Rajashree Mahavihar

I Baha Bahi Buddhist monastery is an example of architectural refinement where the intricacy of its dimension design is even to be found reflected in the particulars of the wood carvings. It can be assumed from the fact that a king was present at the ceremony to mark the foundation of the I Baha Bahi, that this structure was in some way connected to the ruling Malla Royal Family. Such a conjecture is supported by the fact that the Sanskrit name for the structure, Rajashree Mahavihar, means “Great and August monastery dignified by the King”.

The fact that the dimensions based on the ‘hat’, which was discerned as the unit of measurement used in construction of the old royal buildings of Nepal, were also to be found used in a similar manner here and there in various places in the foundations of I Baha Bahi, permits conjecture that this was due to the historical background or lineage associated with the foundation of the building [4].

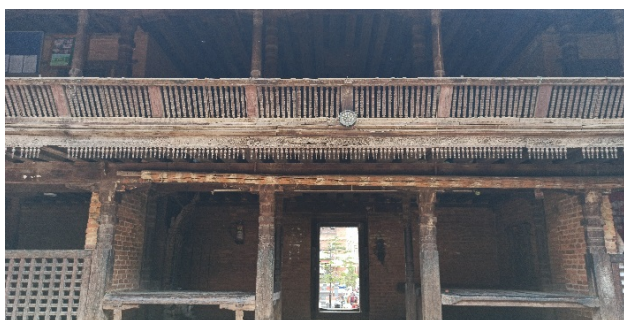
**Figure 13:** Deteriorating Condition of Wooden Components

Although the Japanese team had done an impeccable job of restoring the Bahi complex, the monastery is observed to be in a deteriorating condition at present due to negligence of the government and the community regarding the maintenance of the monument. The revitalization project carried out by the Nippon Institute of Technology has withstood the challenge of weathering and age in many aspects including the structural stability of the building and absence of vegetation on the tiled roof. The building remained unaffected by the major earthquake of 2015, which had damaged multiple monuments in and around the Kathmandu valley. There has been no major degradation in the aesthetic and structural components of the monastery since the year of the restoration to the present. However, a few components such as the wooden Jhallar hanging below the balcony projections and railings of the inclined balcony are observed to be partially or completely damaged or have fallen off entirely and gone missing due to neglect. The Japanese had restored and used genuine components rescued from the original ruins of the monastery and incorporated them into the new revitalized building.

The regular use and maintenance of such a historical monument is vastly necessary to ensure its longevity and significance in the community. Museums could be set up in order to attract visitors which can generate revenue of maintenance and social activities. More socio-cultural and religious activities can be encouraged and regular exhibitions can be set up to promote the area. The history of the Bahi's establishment and the restoration project needs to be well-documented and displayed graphically in order to capture the attention of visitors. Through these measures, the durability and value of this archetypal monument can be restored and rejuvenated which could in turn act as a stimulus for the revitalization of many other abandoned monasteries of the valley.

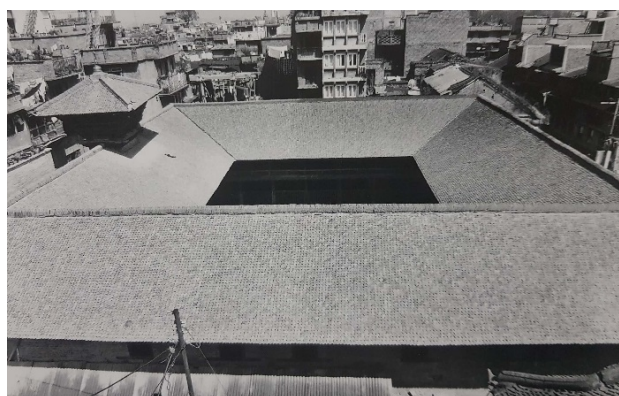
**Figure 14:** Birds eye view after restoration [4]

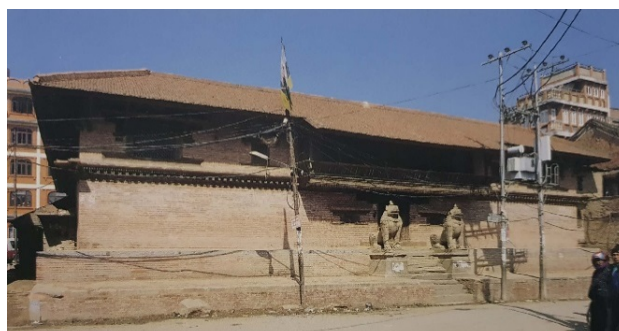
**Figure 15:** Facade, East wing after restoration [4]

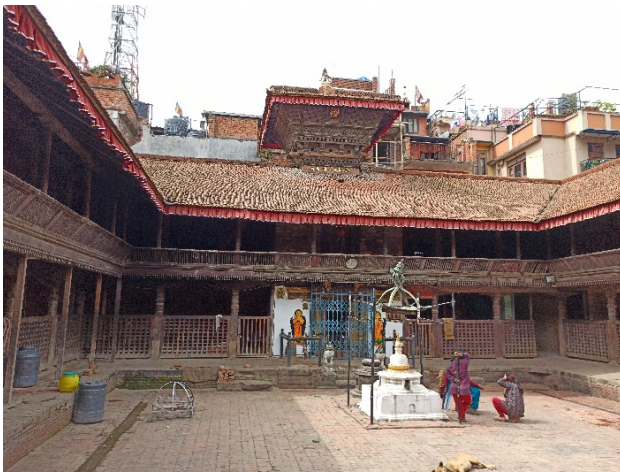
The plinth stones and tiles of the courtyard weren't

replaced during the project and thus they are observed to be in a more deteriorated state in comparison to any other components of the complex at present. The pinnacle of the chaitya on the courtyard also seems to be in a dilapidated condition due to weathering and age. Before the restoration, the Bahi did not have any restrooms. Separate male and female toilets were also added to the building during the restoration. At present, the monastery has been out of use for the most part except for the Sugat Bouddha University classes at the north-eastern part of the building and the single-family residence housing the caretakers of the Bahi at the northern part. Besides the occasional committee meetings and infrequent social affairs of the community, the Bahi seems to be abandoned and largely overlooked by the public.

**Figure 16:** Present Situation of Courtyard and Chaitya
