# Pelton Runner Erosion due to Cavitation : A Case Study of Storage Hydropower Plant, Kulekhani First Hydropower Station

Narendra Mandal <sup>a</sup>, Tri Ratna Bajracharya <sup>b</sup>

<sup>a, b</sup> Department of Mechanical and Aerospace Engineering, Pulchowk Campus, IOE, Tribhuvan University, Nepal

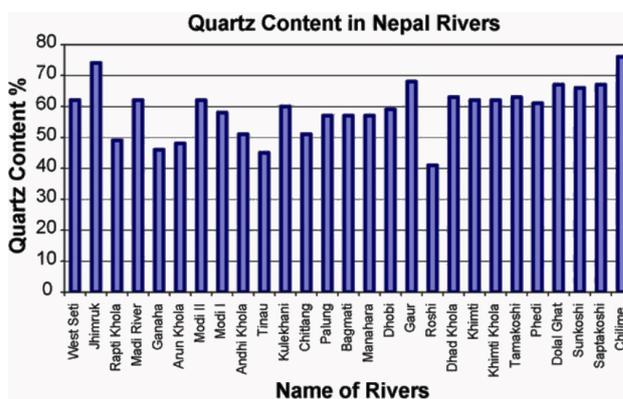
**Figure 1:** Figure 1 Average quartz content in the rivers of Nepal

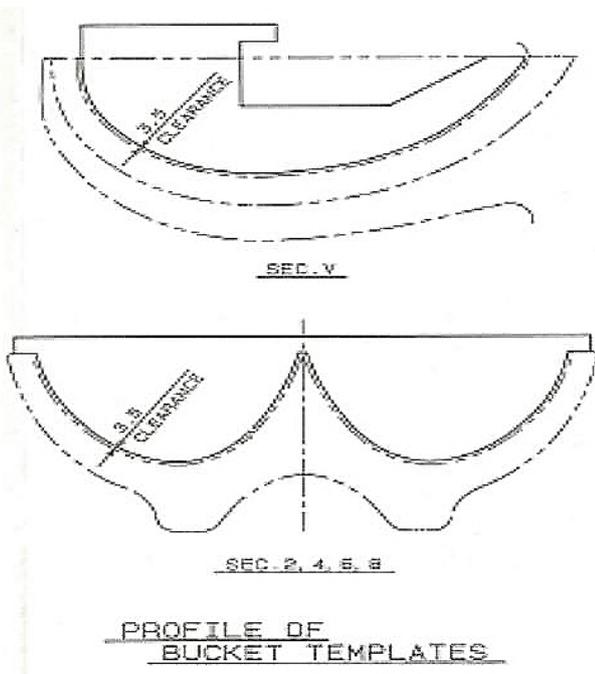
Figure 2: Runner bucket drawing KL1

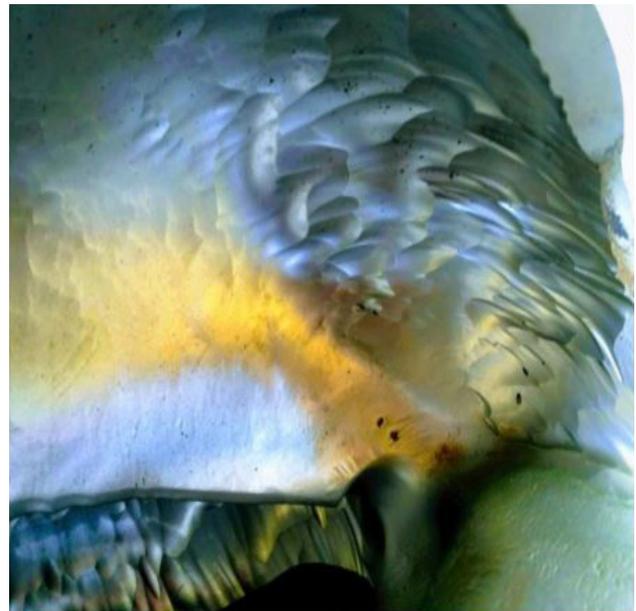
Visual comparison of photographs shorted during 2009 and 2021 were done and noted the patterns of

erosion due to cavitation. Erosion affected area as per KL1 Operation & Maintenance Manual were marked properly. Pattern of cavitation on runner bucket was mostly appearing at splitter nose back side zone. Similarly photograph of Puwa Khola HPS operating with Pelton turbine were also included and noted the pattern of erosion due to pitting mostly on bucket profile. As measurement work was rigorous so sample two buckets were only measured for this study assuming similar wear occurrence in almost nineteen buckets of runner.

Figure 3: Pitting Puwa Khola HPS and Cavitation Pattern

- Visual and photographic analysis reveals the patches of cavitation phenomena are seen mostly on buckets splitter tips backside area along with bucket surface as well
- Complete erosion of splitter tip is initiated by cavitation, analyzing historical records.
- Efficiency trend lines are found.
- Sediment analysis results like sediment concentration and mineral content are known.

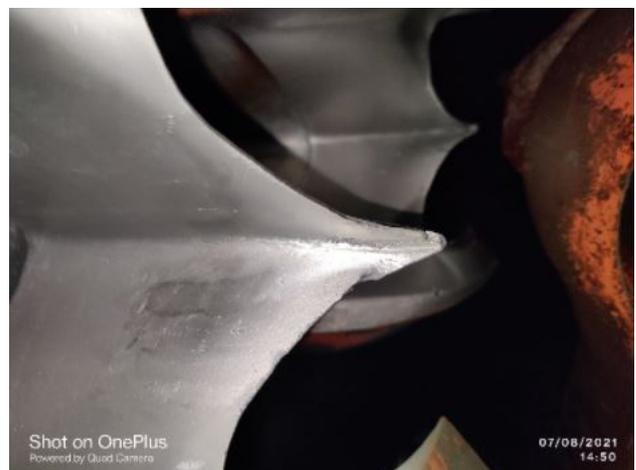
Figure 4: Initiation of Cavitation-i

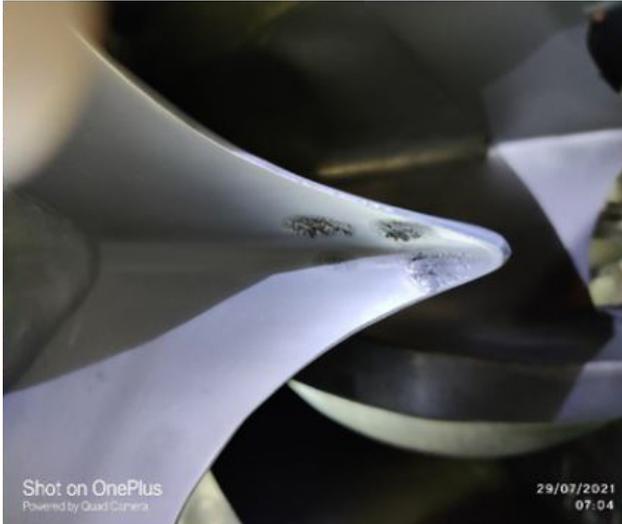
**Figure 5: Initiation of Cavitation-ii**

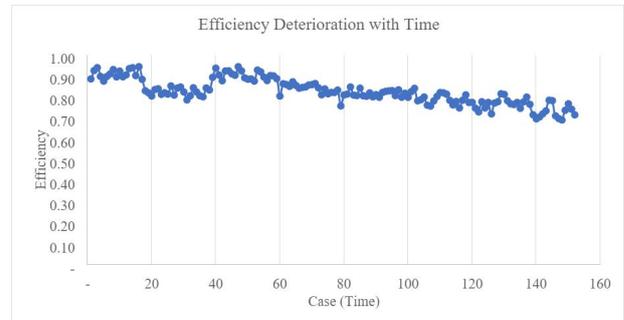
**Figure 6: Plant efficiency trend line**

- It was seen that the plant efficiency is decreasing with years and thus overhaul is required to maintain desire plant efficiency.
- Last 12 years of operation the minimum recorded efficiency of plant was 0.69 and with the maintenance of nozzle & needle the higher efficiency recorded upto 0.94.
- It was seen that the high efficiency was observed at high reservoir water level of around 1527 meter.

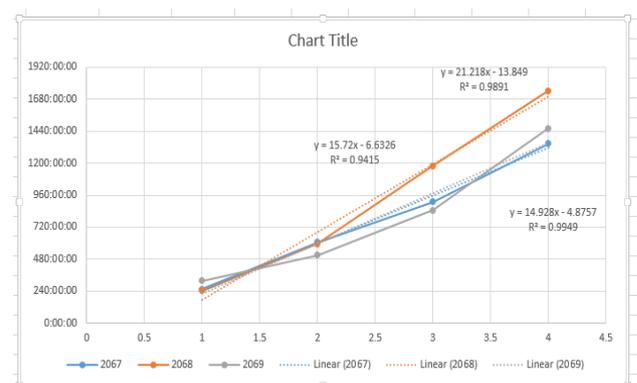
**Figure 7: Running hour trend line.**
