Conservation of Heritage: A Study of Reconstruction of Mahalaxmi Temple at Balambu

Abstract

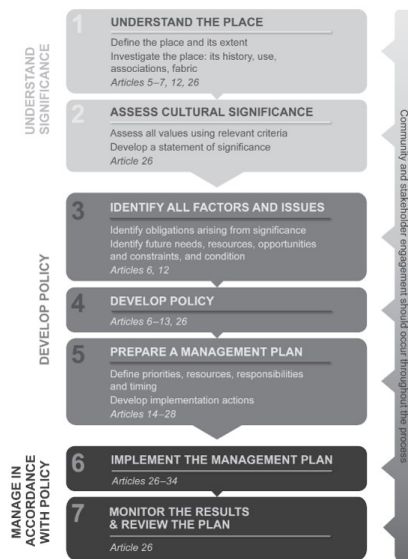
Figure 1: The Burra Charter Process of Architectural Conservation

Typically the conservation process deals with the three main stages of documenting, analyzing and action. This can be seen in the process of conservation as given in the Burra Charter in three phases of understand significance, develop policy and manage in accordance with policy.

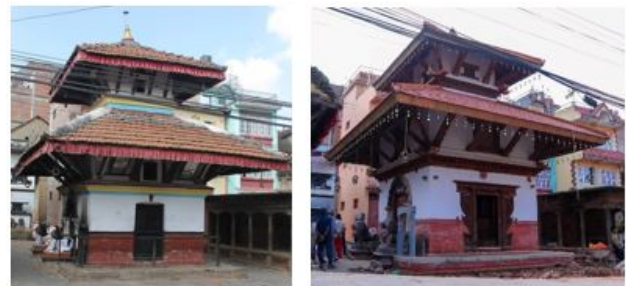
Figure 2: Mahalaxmi temple before and reconstruction

The temple is a two tiered temple; 30’3” high with a base of 13’5” x 13’4” on the ground floor. The temple had wooden carved doors on the main entrance to the southern side. There are doors on three facades all except the northern façade which has a lattice window on the ground floor. The doors on east and western facades are simple wooden doors.

The upper two levels have lattice windows on all four sides. The brick walls are whitewashed. The jhingati tiled roof is supported by timber structure. A stone plinth surrounds the temple. A stone toran can be seen above the entrance of the temple. Two pairs of stone statues of lions can be found on either side of the entrance. The struts which support the two tile roofs are carved with Matrikas and Bhairab. Inside the temple, stone statues and stones representing deities are placed in a linear manner. The stone statue of Mahalaxmi is placed at the center.

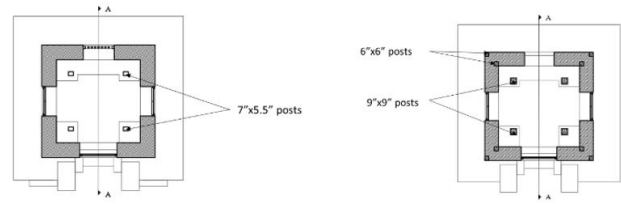
Figure 3: Ground floor plan old (left) and new (right) showing additional posts for reinforcement

Various structural changes were made to improve the structure of the temple building. This includes increasing foundation depth, increasing size of posts, addition of reinforcements to masonry walls on both floors and change in rafter plan with addition of rafters. Rafter plan changes and increase of post size is to accommodate the increased weight due to change in timber type from salla to agrath.

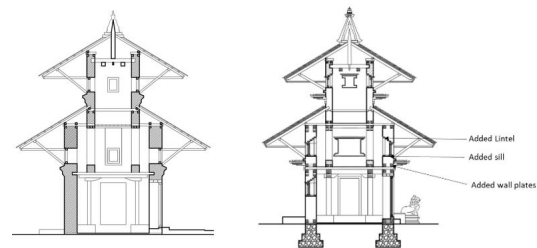
Figure 4: Section old (left) and new (right) showing wall plates added and increased depth of foundation

Wall plates of timber were added on three levels along the wall height which also acted as sill and lintel for the windows and doors.

From the interviews with conservation experts however, the reconstruction did not follow proper procedure. For example, the foundation of the temple was excavated and deepened. The failure to the temple structure was not due to the existing foundation that had withstood the earthquake. Instead of reusing the foundation, the land was disturbed and any detail study regarding soil type, mortar use was not done. Use of modern materials should be done when traditional is no longer available. But the temple was reconstructed with use of modern materials such

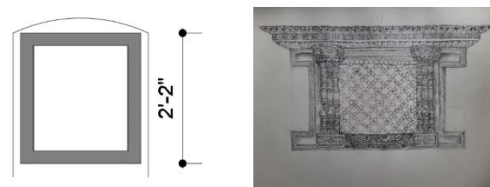
Figure 5: Northern window ground floor old (left) and new (right) showing embellishments in carving

Embellishments and decorative changes to the design were made as per the decisions of the local community and committee. These can be seen in the use of decorative brick layers in the plinth and exposed brick portion of the ground floor. The cornice is also changed from plain brick layers to carved wooden layers with addition of carved wooded eave ends called fyo. The old stone gajur is reused but is gold plated and additions of pataka and kusha are made to it. The doors and windows are ornately carved replacing the plain wooden ones before. The plain wooden doors of the main entrance to the south is reused but copper plated with carvings of astamangal on the copper plate.

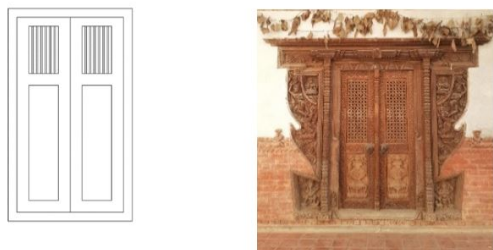
Figure 6: Side door old (left) and new (right) showing elaborate carving in new design

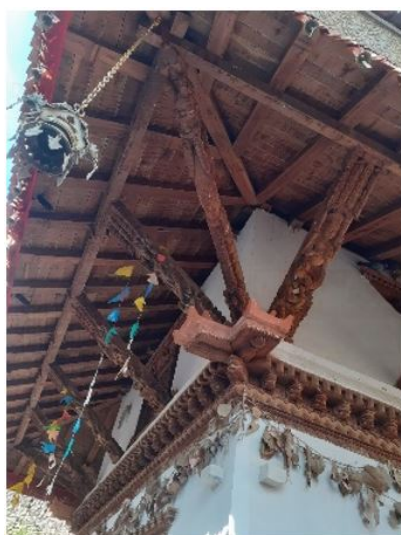
Figure 7: Carved cornice and struts in the south east corner

The number of struts in the lower roof remains 20 from old temple to new. For the upper roof the number of struts is reduced from 20 to 12. In the old design only 7 struts were carved on the lower roof and 4 were carved in the upper. The carved ones have images of matrikas and bhairabs. Most of the struts in the original were plain whereas all struts in the new building are carved with images of matrikas and bhairabs.
