Conservation of Jestha Varna Mahavihara: Past and Present Condition

Abstract

3.1 Condition of the Mahavihara before the Reconstruction

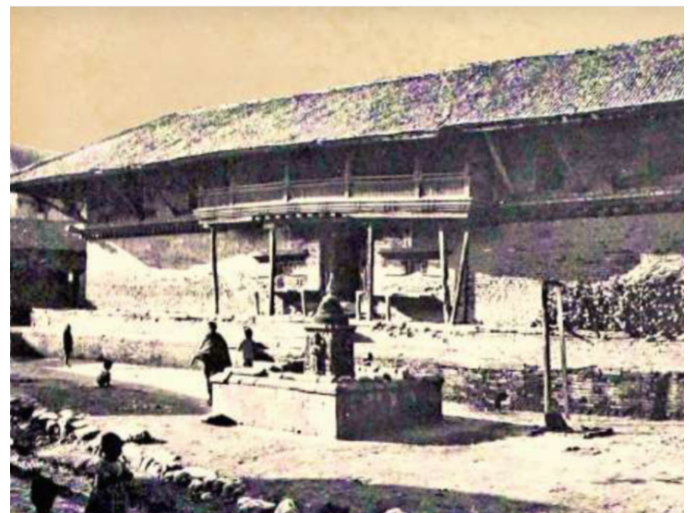
Figure 2: An undated archival photograph of Jestha Varna Mahavihara Complex (INTACH Nepal, 2022)

Jya: Baha Bahi is located on the south side of the road and faces north. It is set slightly back from the road. There is a small square or plaza in front of the building. The foundation of the North façade built on a double plinth, some 1.5 meters higher than the road (see fig 2).

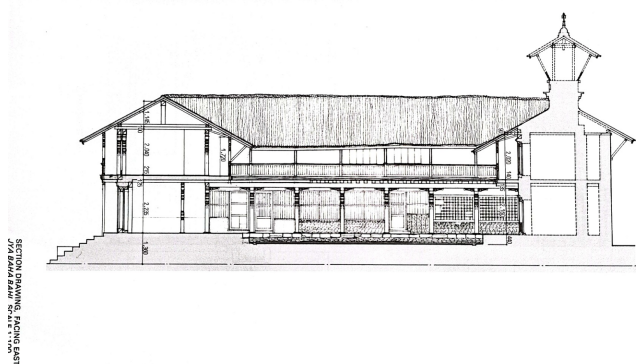
Figure 4: Sectional Drawing: Facing East [2]

The first floor is reached by a single staircase that is located on the south east corner of the building. On the first floor, wooden joists extend beyond the floor itself to form a balcony overlooking the courtyard. The eaves are supported by pillars and wainscots that have been inserted into the spaces between them as handrails. Back from the pillars that form an edge to the balcony is another row of pillars found on the ground floor. With the exception of the shrine, the small partitioned rooms (monk living quarters)

in both the east and south wing are aligned with the corridor. A turret with an appearance like that of turret tops the roof of entrance to the walkway around the shrine. The walkway is closed with a wall in the same way as on the ground floor. In contrast, the central part of north wing is very open with wooden lattice between the pillars and above-mentioned balcony jutting outwards over them (fig. 4 5).

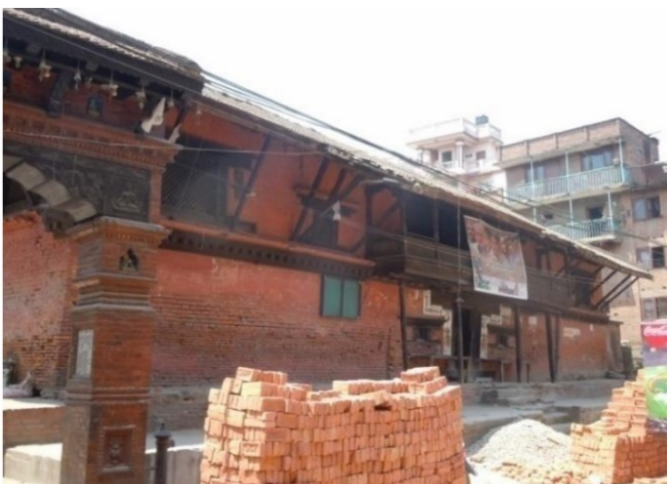
Figure 6: Dampness and Bulging out of Certain portions of the Outer Walls

On the front façade, on the left-hand side of main entrance, the bulging out and caving in if cracked walls could be seen throughout the elevation (fig. 6). Also on the west façade, the bulging out of walls along with cracks as wide as 3cms could be seen (fig. 7). On the edge of the roofs on all four facades, the tiles had fallen off and the rafters was well as eaves board had been slowly crumbling due to penetration of rain water.

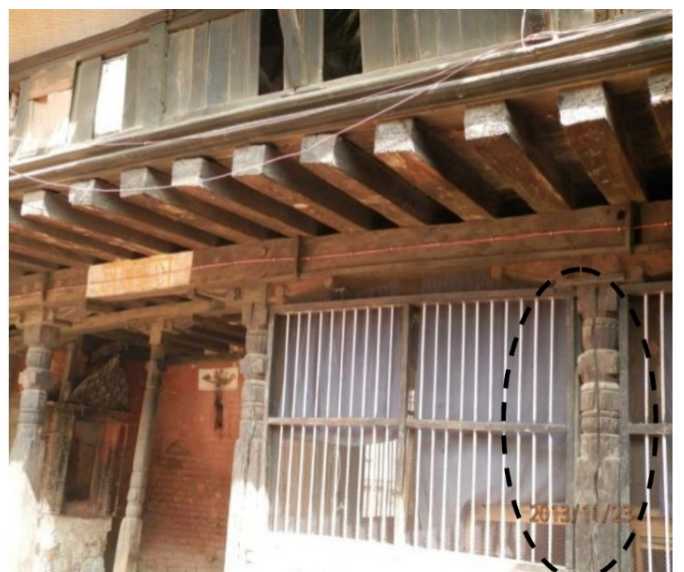
Figure 8: Tilted column and cracks on column

At the interior facades of the baha bahi, the wooden columns of 11cm x 11cm were observed to be tilted. It could've been the

result of movement of the structure during the earthquake. At the Northern façade, most of the columns had cracks in them (fig. 9). The roof had been an extremely dilapidated condition. The tiles had fallen off from large portions of the roof.

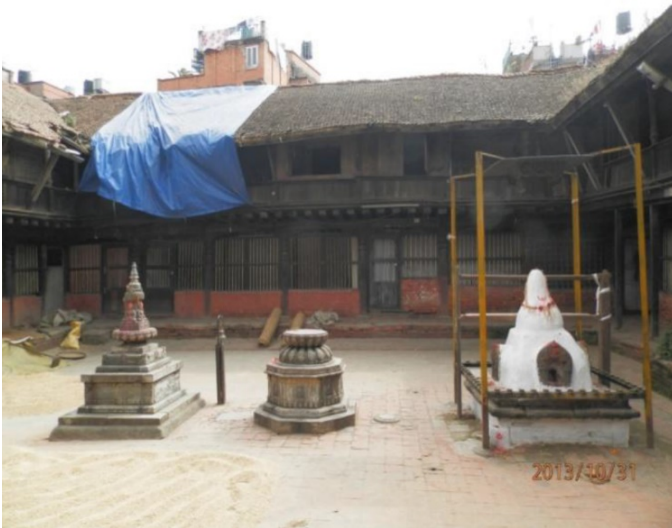
Figure 9: Roof crumbling down on East Facade

Due to penetration of rain, the wooden components of roof had started to decay, which had resulted in the roof being unstable and the spaces beneath had been rendered unusable. Plastic sheets had been placed over the roof in an effort to keep rainwater out (fig. 9). Recently this portion of roof had been repaired with financial support from the Department of Archeology (DoA).

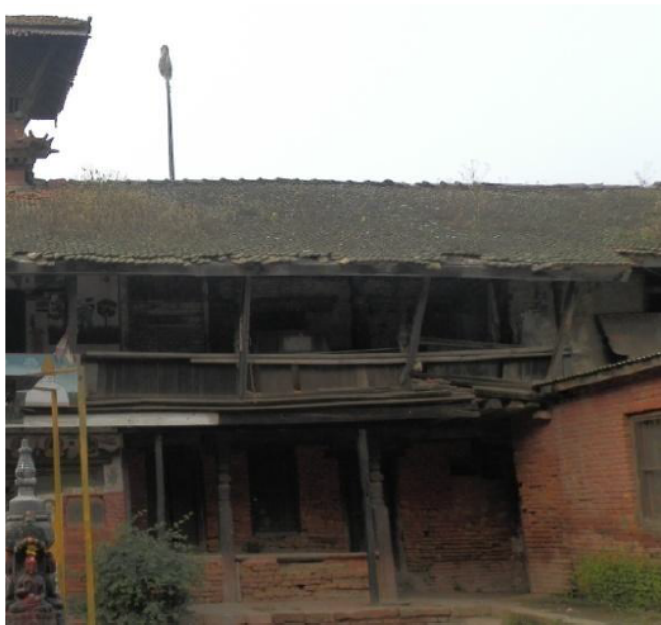
Figure 10: South Wing Verandah in bad condition

The interior southern façade, the south west corner of verandah seemed as if it could fall down at any time (fig. 10). The wooden beam running from east to west had detached from the joints and had cracks in it. Over the roof, large amounts of vegetation had grown due to lack of maintenance (fig.11). At the North wing, over the verandah, the wooden planks which functioned as parapet had fallen out. Deterioration of dalins caused by termite attacks could be observed.

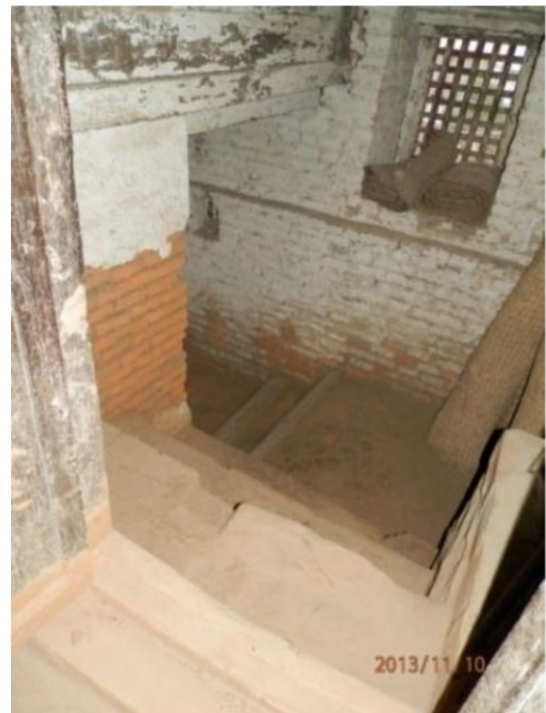
Figure 12: Mud plaster of staircase had crumbled down

While going up the staircase, mud plaster could be seen falling off the walls (fig.12). The fallen roof tiles had been stored on the lobby of east wing.

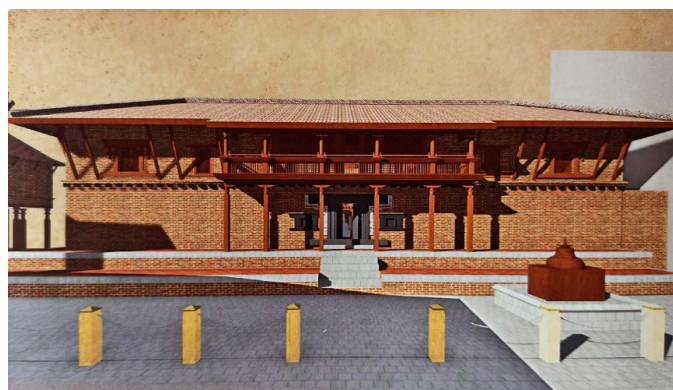
Figure 17: Proposed Northeast Facade

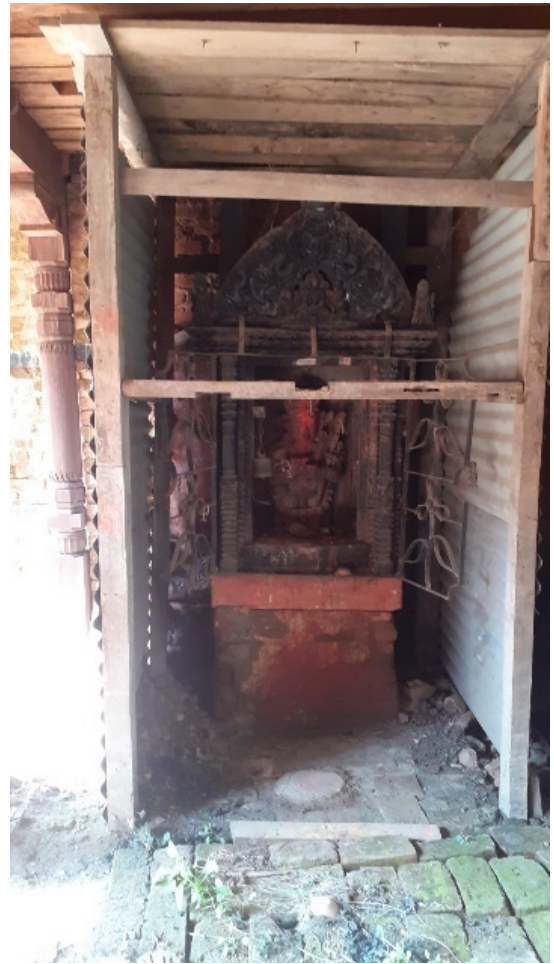
Figure 23: Mahankal shrine at the entrance

The room initially used as accommodation space for the Bajracharya priest has now been converged with the rest to create a large open floor plan. The exact function of each space/room in the Bahabahi has not been determined as of yet. The stairs were originally located in the southeast and west. A new staircase will be added in the in the Northwest corner. As per the new layout, the ground floor has been planned to serve as the local museum and tourist attraction which will be an income source to fund the cleaning, maintenance and management of the Mahavihar. Mr. Tamrakar also mentions that the Tikijhya western wall of the first floor has been removed. The various iconography on the exterior and interior façades have been either replicated with attention to each detail. In some cases, such as the wooden idols on either side of the tikijhya shown in fig. 24, the original idols have been salvaged and preserved to be install back in the same exact location. Similarly, original as well as newly replicated the wooden columns (tham), as seen in fig. 23 are used in the reconstruction.

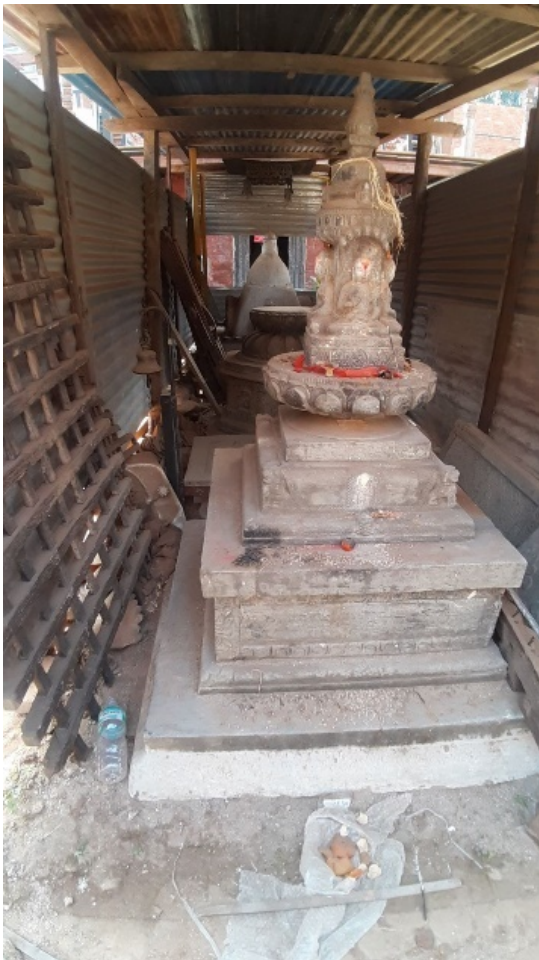
Figure 22: White chaitya, sumeru chaitya and dharmadhatu mandala in the courtyard

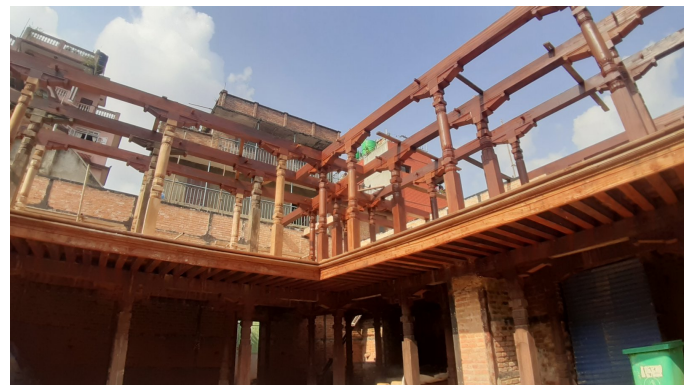
Figure 24: Use of old and new woodwork; shorter joists joined together to create longer joists

The mortar being used for the reconstruction work is the traditionally-used mixture of lime and surkhi sourced from India, which is believed to be better than the conventional cement mortar. In the original structure of the Baha Bahi, the used of Saal timber for all woodwork could be observed. Now however, Agrakh is being used for timber components. According to Mr. Tamrakar, the single piece wooden joists (dalin) spanning the entirety of the rooms were used in the initial construction. Since large pieces of natural wood are difficult to source nowadays, two or more shorter joists are joined together to form a larger joist in the reconstruction. A vertical column (Tham) is placed beneath the joints of the joists to secure them. Due to the area of the space below is obstructed by the columns,

whereas in the past, the larger joists allowed for larger uninterrupted interior spaces. All timber and pre-made woodwork used in the reconstruction has been sourced from Bhaktapur. The foundation is built of brick. Mr. Tamrakar believes that the contractor involved in the reconstruction work, INTACH is knowledgeable, resourceful and considerate about the history and cultural significance of the monument. Skilled woodworkers have been hired from Kirtipur, while all other labourers involved are from Terai region.
