Lighting energy efficiency in Museums; A case of comparison between museums of Nepal

Abstract

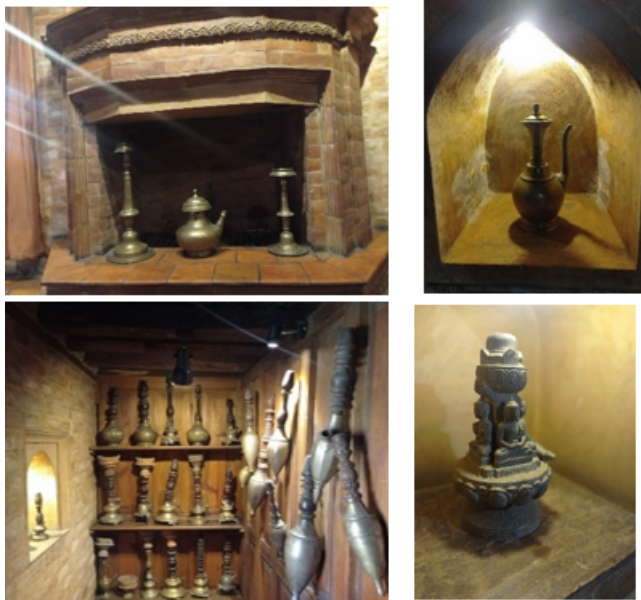
Figure 3: Artifacts displayed at Namuna Ghar

Different artifacts made up of wood, metal, terracotta, paintings etc. were exhibited here. Elements representing Newari architecture was displayed here. The elements were displayed in the niches made in the walls. The entire house had spaces exhibited as living space, workspaces, kitchen dining spaces, study spaces and so on following the functionality of a typical Newari house.

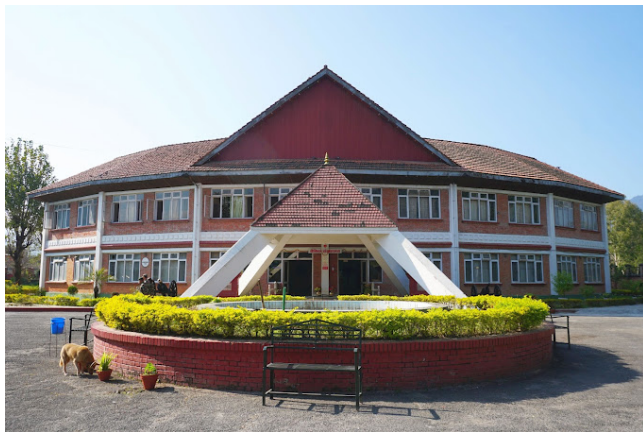
Figure 9: Exterior facade of Military museum

Despite the presence of exterior openings in the building as shown in Figure 9, they have been effectively sealed off using cardboards and plywood, resulting in a deliberate absence of natural lighting within the museum. This strategic choice directs the lighting conditions entirely towards artificial sources as shown in Figure 10. The illumination levels of each artifact was done with the help of lux meter. In places where the direct measurement of lux levels could not be done, the measurements were taken from the surface just outside the glass. In the place where the glass shelf could be opened, the difference in measure of lux value at the surface of glass and inside the glass was done and it was found to be around 100 lux. So, in each data taken at surface of glass which could not be opened due to security reasons, 100 lux has been added to its lux value. The collected lux data was averaged for metal artefacts and paintings and were compared with the standard data which is shown in Figure 11.

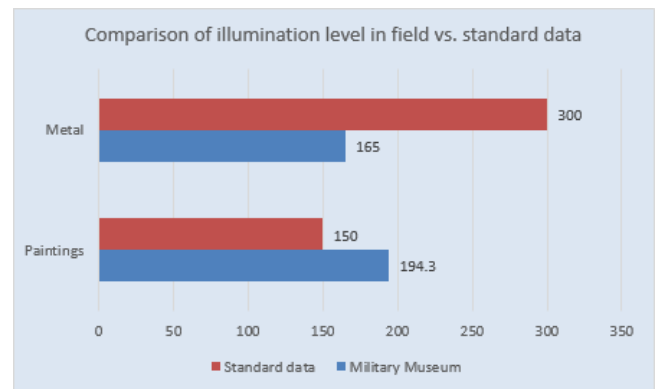
Similar to the findings in the two other surveyed museums, as shown in Figure 11, this museum also demonstrates a disparity in illumination levels. Paintings are subjected to excessive lighting, potentially risking their preservation, while metal artifacts suffer from inadequate lighting conditions that may hinder their visibility and appreciation. Notably, the variance between the surveyed illumination data and the

standard benchmarks appears to be narrower in comparison to the other two museums, indicating a relatively more aligned approach in this museum.

Figure 11: Comparison of illumination level in field vs. standard data

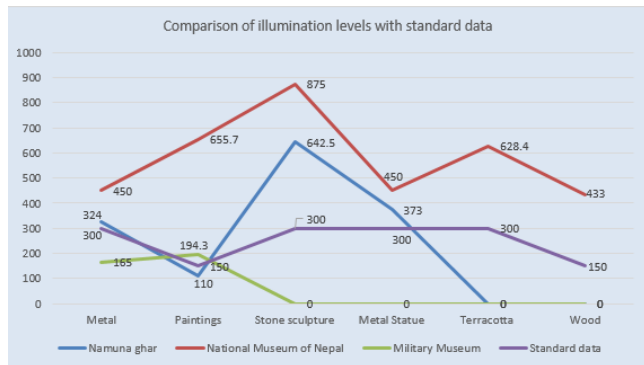
As per Figure 12 shown below, we can finally draw some findings of the research. The minimum illumination level should not fall below 50 lux. The illumination level for low sensitive objects, medium sensitive objects and high sensitive objects were found to be 300 lux, 150 lux and 50 lux respectively. None of the three museums surveyed have met the illumination standards as per the literature standards. The artifacts are either subjected to inadequate illuminations or excess illumination levels. In case of inadequate lighting, the visitors will be unable to clearly see the artifacts. In case of excess lighting, the intensity of light for a longer term can degrade the artifact, fade its color and even cause the breakdown. Certain amount of energy can be saved from each

museum without affecting the performance of museum. The future generation to come may or may not see this piece of artifact if the lighting intensity persists as of now.

Figure 12: Comparison of illumination data of all museums with the standard data

As a final step of research, all data of each museum were plotted at a single graph to conduct comparative studies in between museums. The comparative study of illumination levels in between different museums surveyed is presented below in graph:
