LEM based analysis of Guthitar landslide along Dharan-Dhankuta Highway

^{a,b} Department of Civil Engineering, Pulchowk Campus, IOE, Tribhuvan University, Nepal

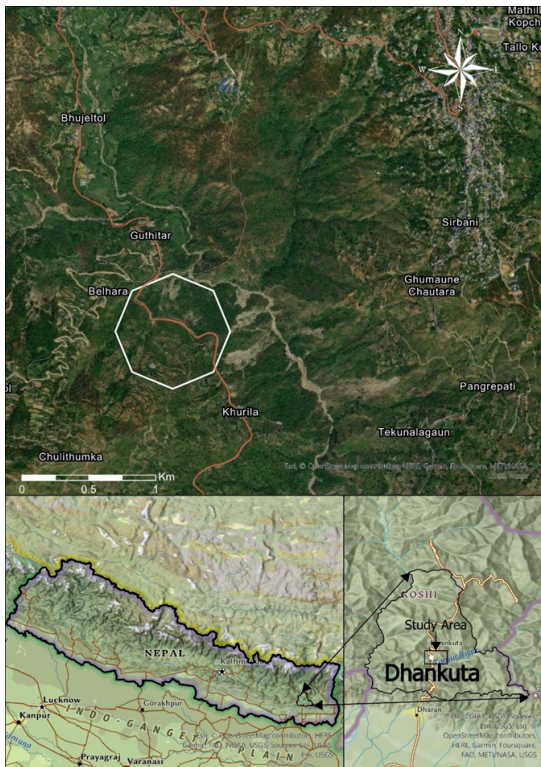
Figure 1: Location of the study area

The troublesome land movement site at Guthitar of Dhankuta district lies about 10 km south of Dhankuta Bazaar. The study area is situated between latitudes 26°57'42"N and 26°57'17"N and longitudes 87°19'15"E and 87°19'35"E as seen in Figure 1.

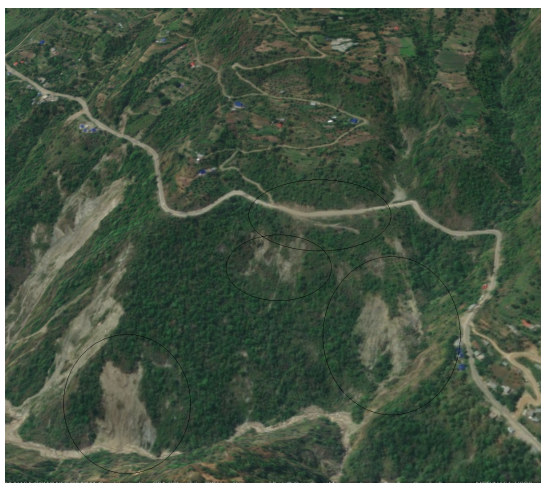
Figure 3: Settlement of road level and activation of local landslides at the bottom part of the slope

Continuous maintenance of the road is required to keep the road functioning. Since small continuous movement of the slope can contribute to a large and catastrophic failure, the underlying problem and mechanism must be acknowledged. Continuous slope monitoring is needed to understand the complex mechanism behind the problem. Various slope problems like settlement of old road, local landslides at bottom of the slope and side cutting by natural streams on either sides of the slope can be seen in aerial photograph of the area as seen in Figure 3

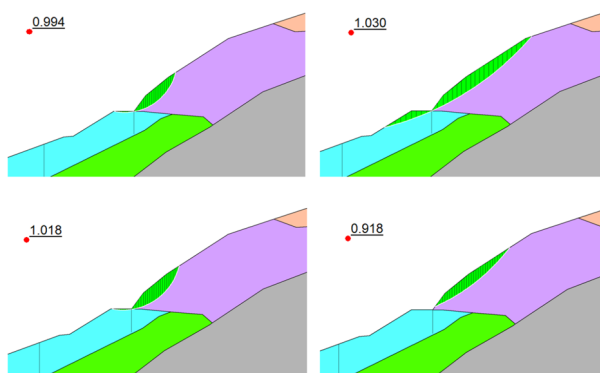
Figure 7: Slip Surfaces near Road section

As is evident from the field data, localized slope failure is occurring at road section of the slopes. This is supported by the analysis as analysis for local slope with different probable slip surface showed failure as the FoS was 0.994, 1.030, 1.018 and 0.918. This is one of the critical local zones of the Guthitar slope. The continuous subsidence of road level and the presence of local landslide just above the road section as observed in the field is accurately predicted by this analysis. The slip surfaces along with their Factor of Safety are shown in Figure 7
