# Post-Earthquake Disaster Risk Management of Cultural Heritage: A Case of Patan Durbar Square

Prajina Karmacharya <sup>a</sup>, Jiba Raj Pokharel <sup>b</sup>, Inu Pradhan Salike <sup>c</sup>

<sup>a</sup> Department of Civil Engineering, Pulchowk Campus, IOE, Tribhuvan University, Nepal

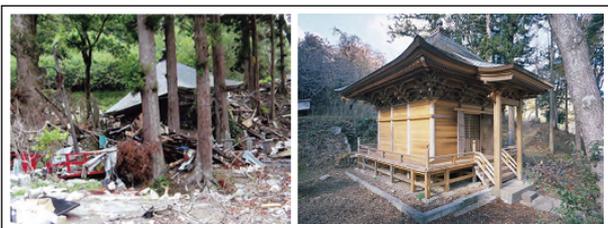
Figure 4: Kannon-do Hall before and after restoration

Tenyi-ji Temple is located in central Ogatsu, founded in the year 1390 had more than 500 parishioner families. Japan was hit by an earthquake on 11th March 2011 followed by the tsunami which destroyed the whole temple complex. Before the earthquake aside from the Kannon-do Hall, there was a complete temple complex including the temple gate, worship hall, priests' quarter, founder's hall, dormitories and bell tower. All these structures were destroyed and Kannon-do hall was also washed away from its foundation, but remained on the temple ground caught by the surrounding trees and is now the only structure standing from the Edo period.

In Japan, there is a long tradition of historic buildings being once completely or partially dismantled for repairs and then being reassembled again. This was

the method chosen for restoration of Kannon-do Hall.

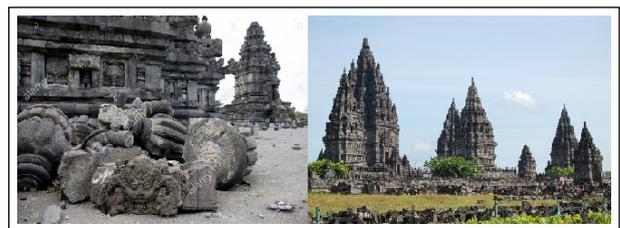
Figure 5: Prambanan Temple before and after restoration

On May 2006, Yogyakarta and some area of Klaten experienced a very powerful earthquake with magnitude of 5.9 on the Richter scale. The earthquake killed 6000 people and many buildings, roads and historical building suffered severe damage including the Prambanan Temple compound. Almost all of its buildings were damaged by the earthquake, to varying degrees and with various types of destruction. There were two kinds of damage: Structural (Cracking, sloping, rusting, deforming, impacted stability of the building) and Material (Stone falling, breakage and shelling).

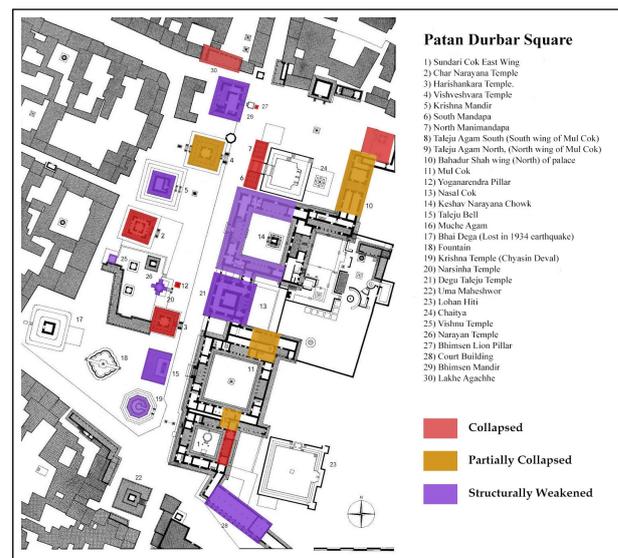
Figure 6: Damaged and Collapsed Monument in Patan Durbar Square

The earthquake of 2015 had a massive impact on the heritage of Patan Durbar Square. As per data collected from DOA, six monuments were totally collapsed, four monuments were partially damaged and five monuments were structurally weakened. The Char Narayan Temple, Hari Shankar temple and Manimandap were totally destroyed leaving only their plinths while Visveshvara Mandir and Bhimsan Mandir were partially damaged.

Another important monument Krishna Temple was partially damaged and maximum damage was seen on the second floor. The roof of the north and south Taleju was also damaged. The earthquake also caused a total collapse of the upper two storey of the east wing's rear façade and the central portion of the first and second storey of the quadrangle's facade.
