# Seismic Vulnerability of Pocket Settlement: A Study of Traditional Architecture of Baglamukhi

Rapid Visual Screening of Buildings for Potential Seismic Hazards  
FEMA P-154 Data Collection Form

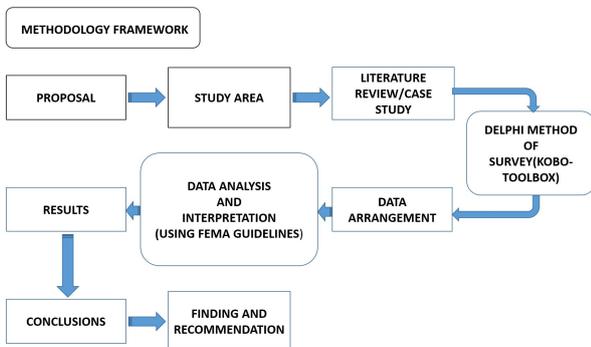
Figure 4: Methodology

The research uses a co-relational research strategy where we first will find out the variables on which viability of traditional or indigenous architecture depends on analyzing the degree of co-relation between the variables that could affect the local architecture. The methodological framework of the study is shown in figure 4.

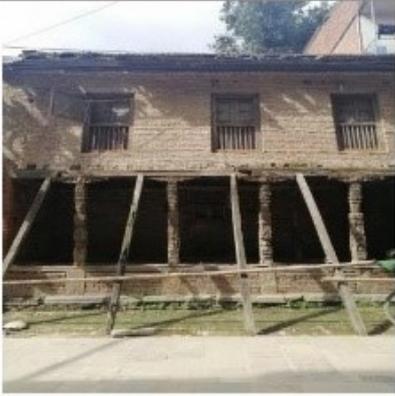
**Irregularities:**  Vertical (type/severity) weak storey/severe  
 Plan (type)

**COMMENTS:**  
on the verge of destruction, shoring given to building, delamination of walls, out of plane failure, rotten timbers, joint failure, slope roofing, leakages
