Sand Erosion in Francis Turbine- A Case Study of Middle Marsyandi Hydropower Station

Abstract

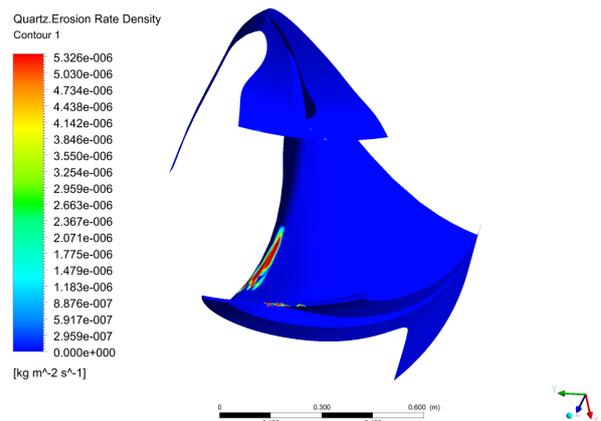
The figure shows the erosion pattern of the MMHPS runner of. It can be observed that the inlet and outlet sides of the blade, specially the leading and trailing edges are highly eroded.

Figure 9: Erosion pattern in inlet side of blade

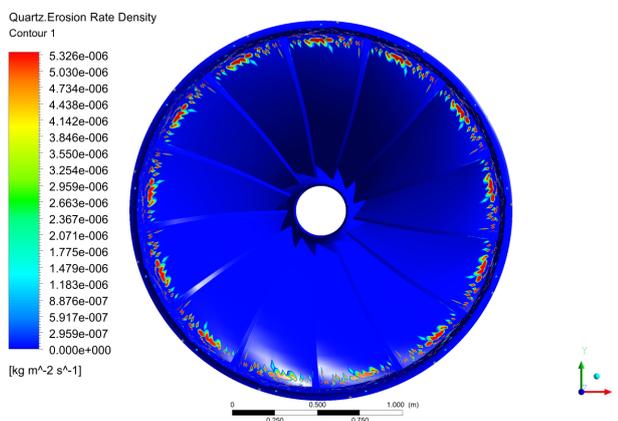
Figure 7: Erosion in runner outlet

The qualitative analysis was done by taking photographs of the dismantled runner along with a flow simulation. Results of both show that the inlet side (leading edge) and outlet side are found to be mostly eroded by sediment. The erosion in inlet side was due to the high velocity impact of water emerging from the guide vanes and outlet side erosion was due to the high velocity of flow, pressure drop and curved profile of the runner blade. Following figures show the results for the erosion pattern at full gate opening by both methods. The validation of the CFD result

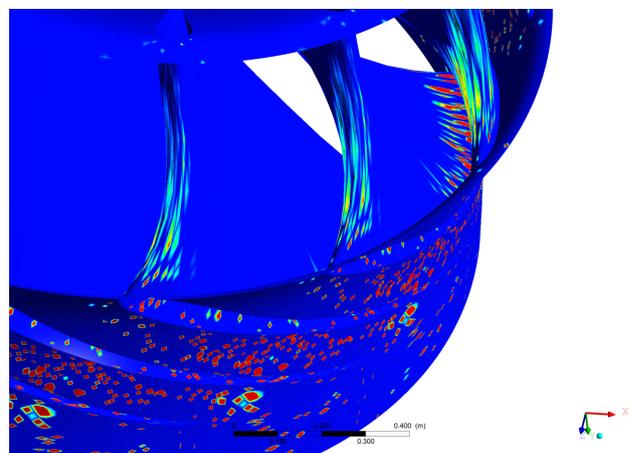
3. Erosion on the surface and outlet of the blade

Figure 10: Erosion pattern in blade surface and outlet of runner

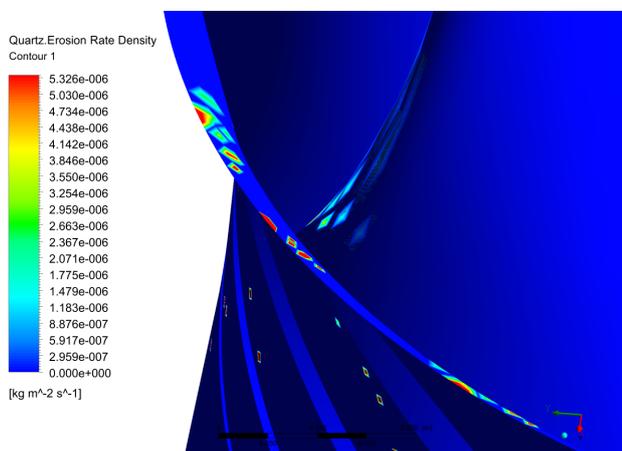
2. Erosion pattern in the inlet side (leading edge) of blade

Figure 8: Erosion pattern in inlet side of runner

Due to the direct impact of high velocity water emerging from guide vane openings, there was substantial erosion on the inlet (leading) edge of the blades. A larger amount of material loss was found at the inlet portion as shown in the figure.

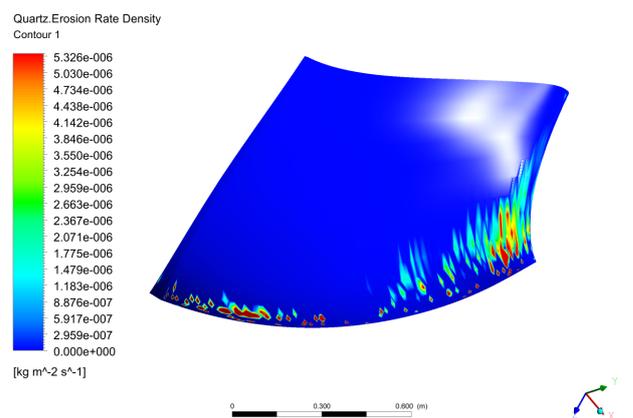
Figure 11: Erosion pattern in outlet side of blade
