Prediction of Cost Fluctuations in Residential RC Buildings due to Seismic Non-Compliance

Abstract

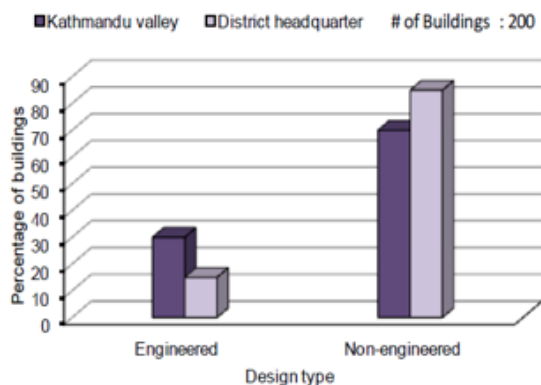
Figure 1: Distribution of % of buildings according to design type

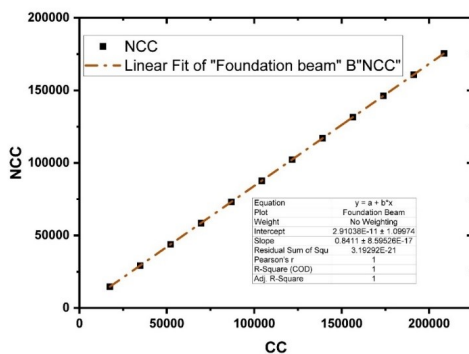
Figure 7: Linear fit of foundation beam

This is a calibration curve plotted complied foundation beam versus non-complied foundation beam. The graph is a perfect linear because cost of twelve non-complied foundation beam is twelve times the cost of single non-complied foundation beam.

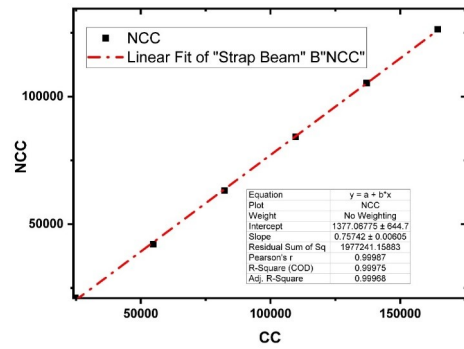
Figure 8: Linear fit of strap beam

This is a calibration curve plotted costs of complied strap beam versus the cost of non-complied strap beam costs. This curve is also a perfect linear as cost of six strap beams are six multiple of cost of non-complied strap beam.

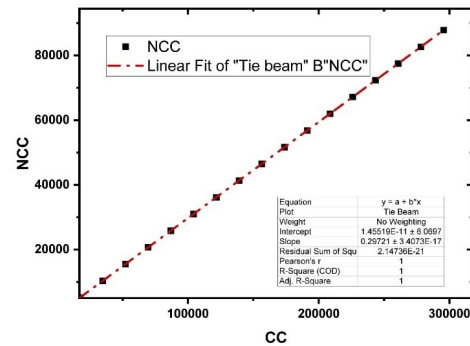
Figure 9: Linear fit of tie beam

This is a calibration curve plotted cost of complied tie beam versus the cost of non-complied tie beam. It is also a perfect linear curve as it is just like a unitary calculation.

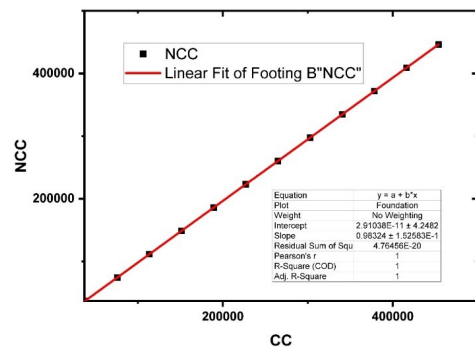
Figure 10: Linear fit of footing

This is also a calibration curve which is plotted against cost of complied footing versus the non-complied footing. All calibration curves are a perfect linear as cost of complied as well as non complied components increase linearly as number gradually increases.

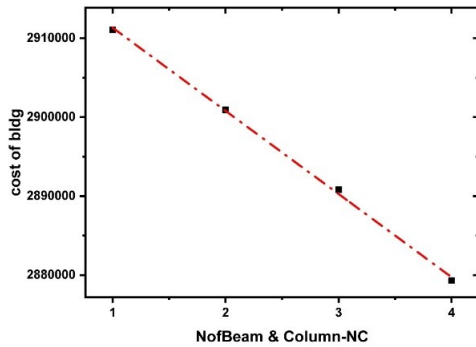
Figure 11: Non-complied beams and columns cost vs Total cost of building when complied

This is a curve plotted total cost of building when complied against the combination of beams and columns non-complied in certain percentage. The combination of non-complied beams and columns are 25%, 50%, 75% and 100% of total numbers respectively. Due to unequal numbers of beam and column, their combination is considered and its cost fluctuation slightly deviated from linear graph.

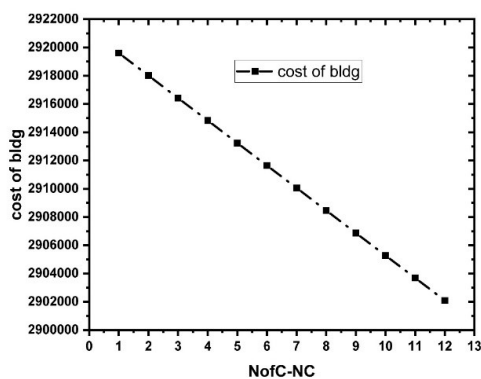
Figure 12: Non-complied columns cost vs Total cost of building when complied

This is a curve plotted cost of building when complied against numbers of beams non-complied and their cost fluctuations can be seen on the curve. The cost deductions due to their non-compliance is gradual.

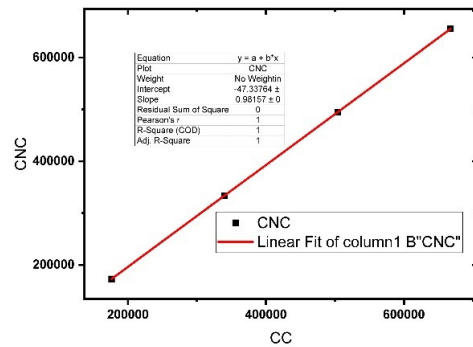
Figure 13: Non-complied beams and footings cost vs Total cost of building when complied

This curve is plotted between a combination of beams and footings in percentage (25%, 50%, 75%, 100%) of their total numbers. 25% of total beams and footings accounted in cost deduction is in left most side while the 100% non-compliance accounted is shown of top right side of the curve.

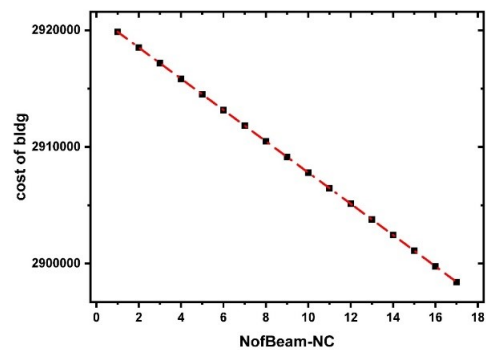
Figure 14: Non-complied beam cost vs Total cost of building when complied

This curve depicts the cost deductions due to non-complied beams when compared to complied costs. The curves here shows the cost deduction tendency as non-compliances seen on sample sites were meant to reduce the costs

Objective two: Estimation of cost variation due to seismic non-compliance in residential RC buildings. The cost deduction due to various non-compliance when studied individually were seen linear. The combination of non-compliances was slightly different than the individual ones. Due to non-compliance the cost is seen to have been reduced to some extent. The graphs plotted on complied columns vs non-complied columns has shown a linear relationship along with the complied vs non-complied strap beams, foundation beams, main beams, etc.
