# Reintegration of Bhaidega Temple: A Temple at Patan Durbar Square

#### **Abstract**

# 1.2 Bhaidega Temple

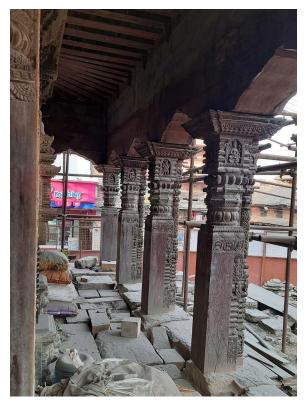
**Figure 14:** Circumabulatory of Bhaidega Temple after 2015 earthquake (*Source: Author*)

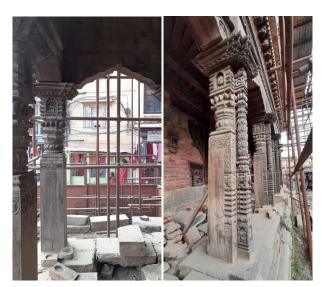
Columns are made up of Sal timber (*Shorea Robusta*); *Agrakh wood.* The wooden column supports a wooden bracket that transfers the load of the temple structure from the lintel and beam to the wooden column.

The circumambulatory consists of 20 timber columns; 4 corner columns and 16 intermediate columns. The corner columns are of single slender units, while the intermediate column has an extra circular column unit attached to its outer face. Five bays are formed by circumambulatory columns on each of the four sides of the temple.

Figure 15: Columns of Bhaidega temple (Source: Author)

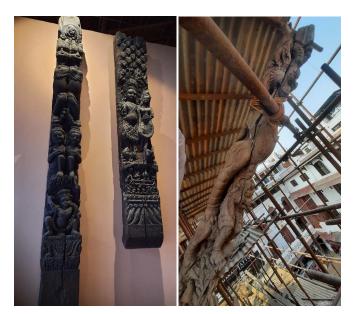
The corner struts—*Kushalan* is the largest struts and supports the most weight. These struts have legendary depictions of the mythical creatures—griffins, with the face of a male, a lion's body and bird's wing. Overall, just one strut, *Kushalan* (corner strut), of the Ground level has been made. There are 3 existing *Kushanlan*. There are 4 corner struts in any tiered temples: 2 males and 2 females. So the missing one has already been reproduced on the basis of the existing 3 *Kushalan*.

**Figure 19:** Strut (left) and Corner Strut-Kushalan (right) of Bhaidega Temple

There are 22 existing struts. The total struts of the temple are 44, among which 22 still need to be recreated. A total of 18 struts are missing, only 6 struts are there of lower roof. Even historians and iconographic artists are involved in the process but are still unable to identify the exact iconography, so the team has not started work on struts yet. Even though the struts need to be constantly replaced due to natural degradation, the positioning of the struts is not random. It follows the systematic rules of tantric iconography. So, the remaining struts have not been replicated yet. Research is still going on for the iconography of the remaining struts.
